DIY DECK RESTORATION

When soft spots spread across our foredeck, we cut deep into the balsa core to get to the root of the problem. Then we rebuilt the deck stronger. By Heather Francis

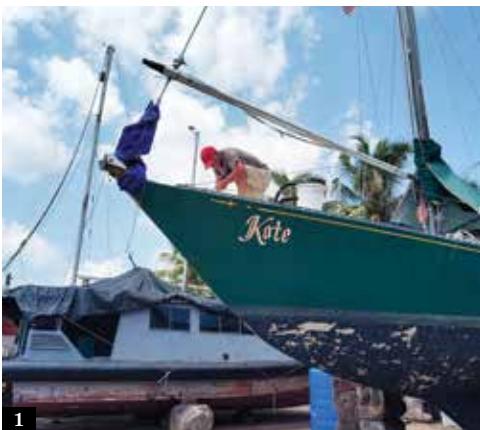
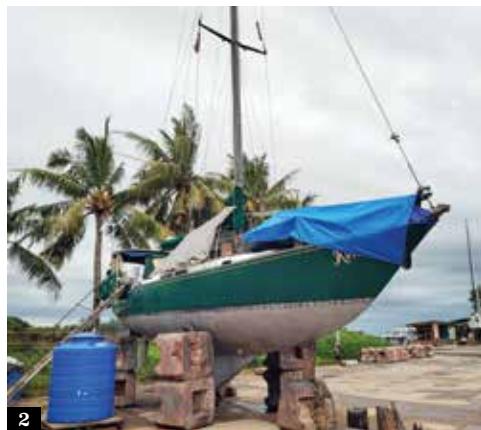
Kate, hauled out in Kudat, Borneo, begins a major deck repair project (1, 2). The first cut into the foredeck is always the deepest, revealing what lies beneath (3). With the deck opened up (4), old electrical wiring embedded in the balsa core comes to light (5). The crew then opens a second section of the foredeck to investigate further and assess the extent of the problem (6). Steve grinds away the original fiberglass deck pieces in preparation for rebuilding (7). By the end, the original deck skins are clean and ready for the next stage of the refit (8).

We decided to tackle the project ourselves. We bought an oscillating saw, a circular saw and a wet-dry vacuum. Then we booked a haul out at Penuwasa Shipyard in Kudat, Borneo, Malaysia. We took a deep breath, and we opened a proverbial can of worms.

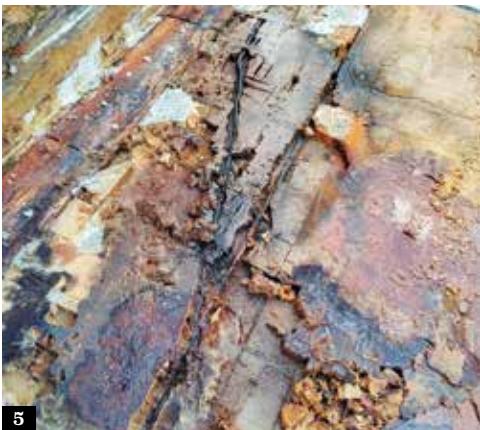
5

With the top skin removed, we got a look not only at the balsa, but also into the history of our boat. We discovered that a piece of marine plywood ran down the middle of the foredeck under the sail track. Curiously, we found a pair of wires running through the balsa core on the starboard side of the plywood. The boat's electrical system had been updated long before we took ownership, so we had no idea that the original wiring had been concealed within the deck. Now, the defunct wire provided a conduit for moisture to flow through the balsa.

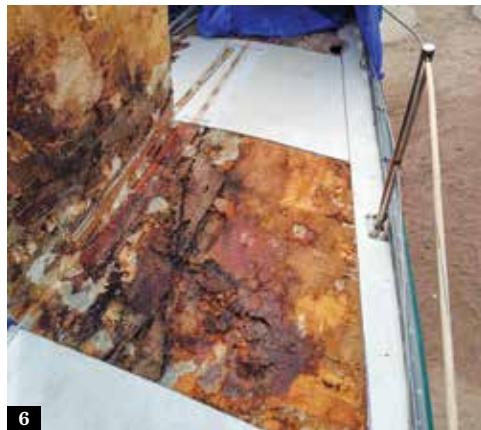
6

the rot went. Steve cut a larger section that covered the starboard side of the foredeck from the toe rail to the centerline, ending about 20 inches from the first cutout. Not only had the wires funneled the water ingress down the starboard side, but we also found a mass of what looked and smelled like tar. The sticky puddle had been injected through holes drilled in the deck. A shortcut solution by a previous owner that disguised the soft spot.

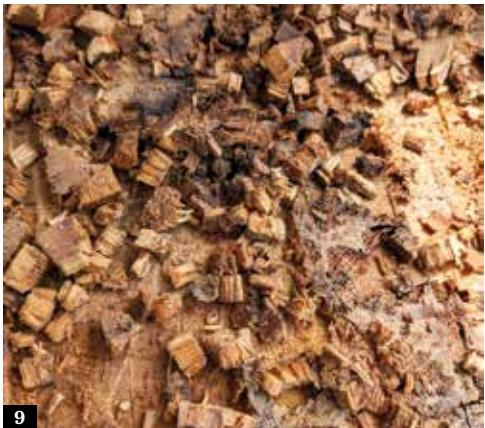
9

The downfall of balsa-cored decks is when water finds its way below the fiberglass skin. Most commonly, this happens when deck hardware is improperly sealed, or the sealant breaks down. Balsa can absorb a lot of water before it begins to rot, resulting in a soft spot. It can be years before damage is noticed, making it difficult to pinpoint how the water ingress occurred.

Rotten balsa core exposed during the foredeck rebuild shows the extent of the damage (9). New plywood blocks are cut to size (10), then carefully dry-fitted until the fit is perfect (11). Once satisfied, the blocks are left to dry on baking paper to keep them clean and flat (12). Fresh batches of resin are mixed and prepped for the day's work (13), coating the foredeck section and preparing it to be glued down (14). With the new material secured, the foredeck emerges fully reconstructed (15), before the team moves on to tackle the coach house (16).

Next was the dirty task of removing the rotten balsa. Armed with a scrapper, a chisel and a lot of determination, Steve spent several hours filling buckets with bits of soggy wood. Some areas peeled away in chunks that resembled canned tuna, juice and all. Others crumbled into a paste and easily scraped away. A few balsa tiles on the outboard edge were dry, so we left them intact.
